Home Inspection Report

1234 Your Street Here

Burlington, ONTARIO L7L 6X4

Inspected on Fri, Jul 6 2018 at 10:00 AM

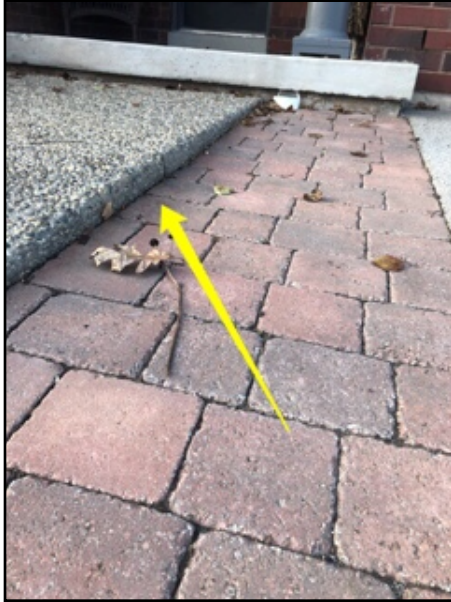
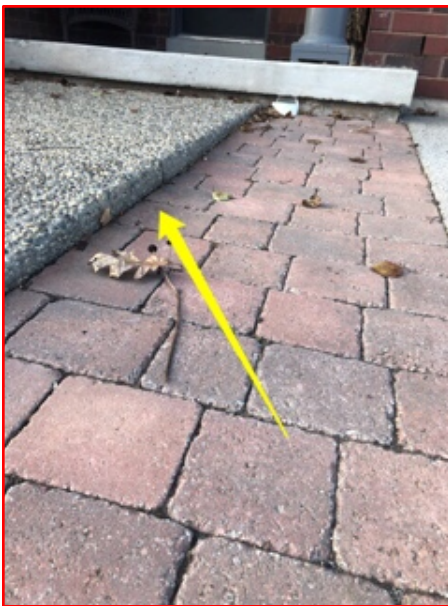
Figure 1-1

Possible trip hazard. This is a safety concern. Suggest repair /replacement as needed to ensure safety.

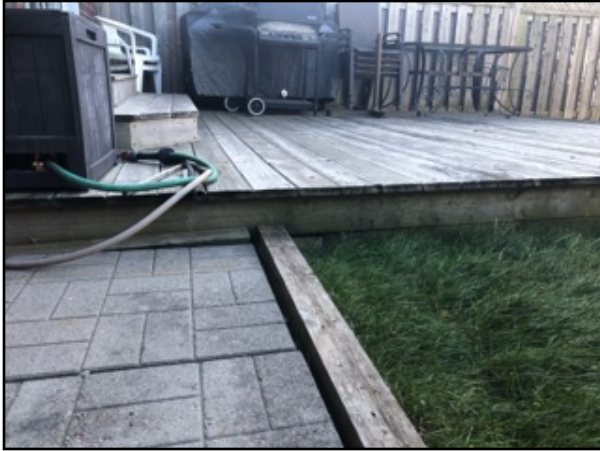
Figure 2-1

Review of structural assembly was limited or not possible due to poor accessibility.

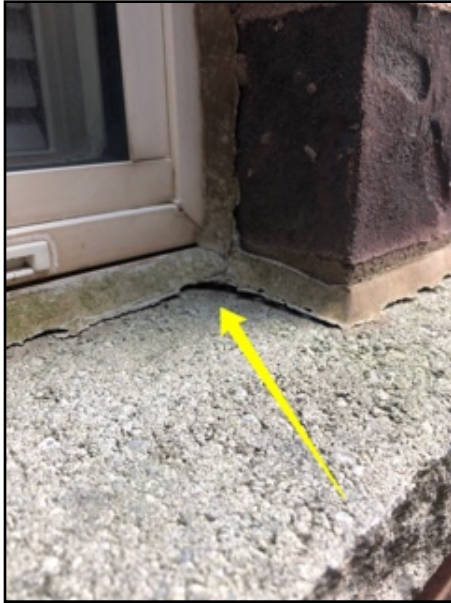
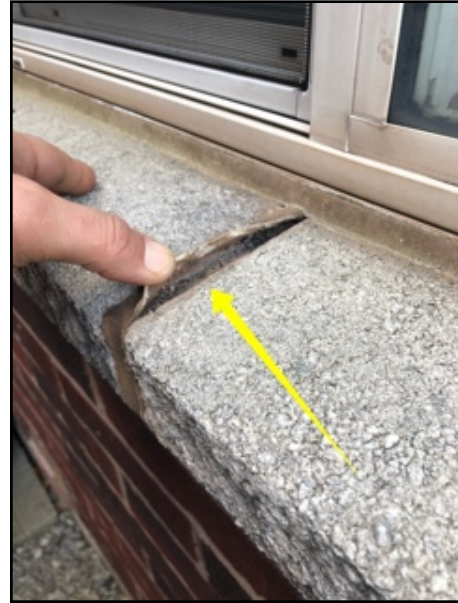
Figure 3-1

Comment 3:
Suggest caulking around doors and windows as needed.

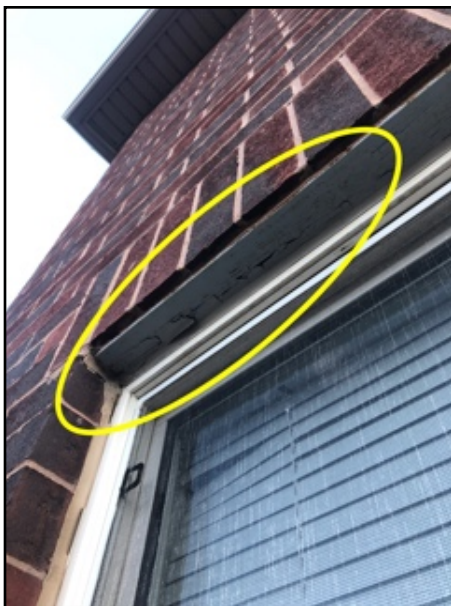
Figure 4-1

Comment 4:
The exterior of the window has peeling paint.

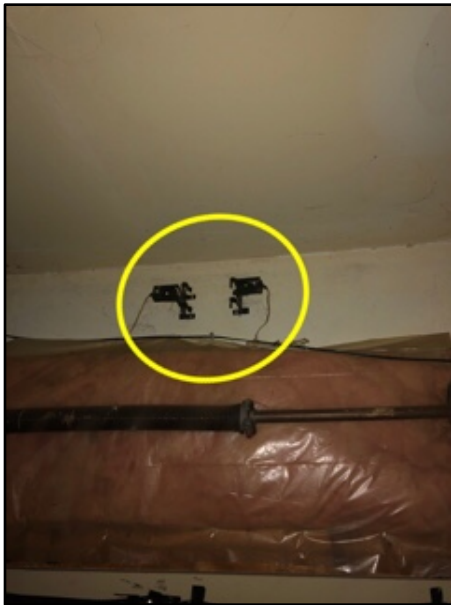
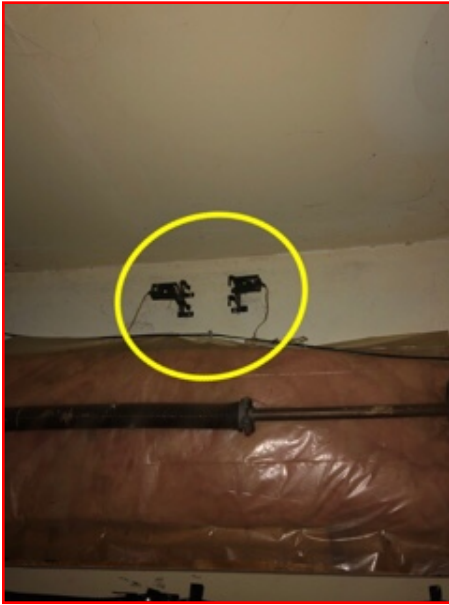
Figure 5-1

Comment 5:
Photo cell for garage door should be 6" off ground. Recommend moving them down.

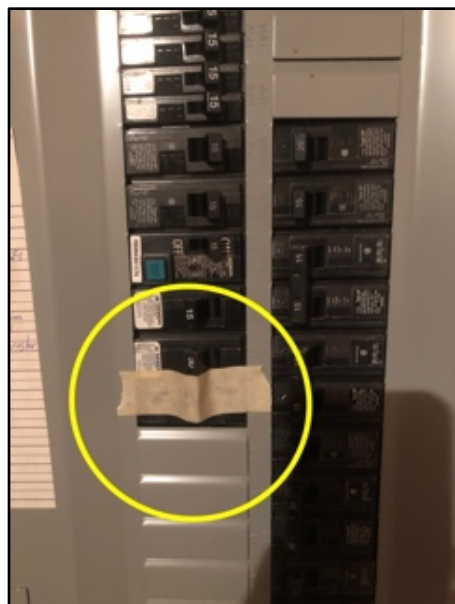
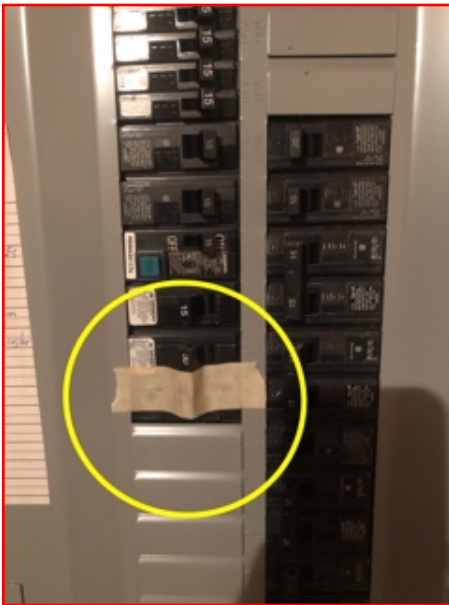
Figure 6-1

The breakers in panel are taped in the off position, unable to determine the reason. Recommend not turning breaker back on until contacting home owner for reasoning.

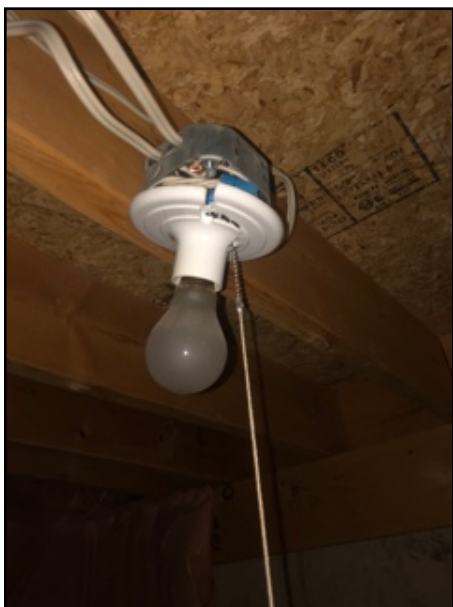
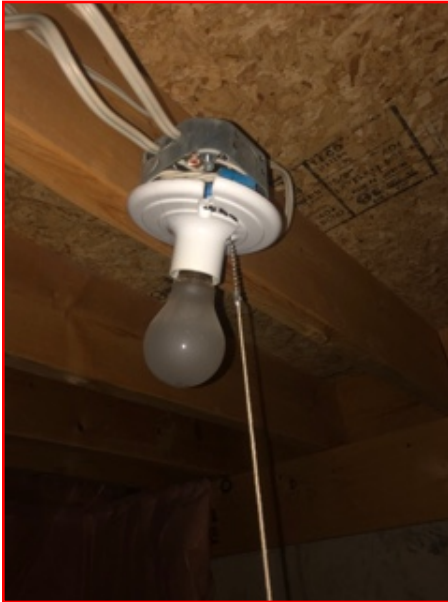
Figure 8-1

The light fixture is cracked or broken. This is a safety concern and should be replaced immediately.
